**CRACK PROPAGATION MODES
IN INJECTION MOLDED
FIBER REINFORCED THERMOPLASTICS**

by
**J.F. Mandell
D.D. Huang
F.J. McGarry**

April 1980

DEPARTMENT
OF
MATERIALS SCIENCE
AND
ENGINEERING

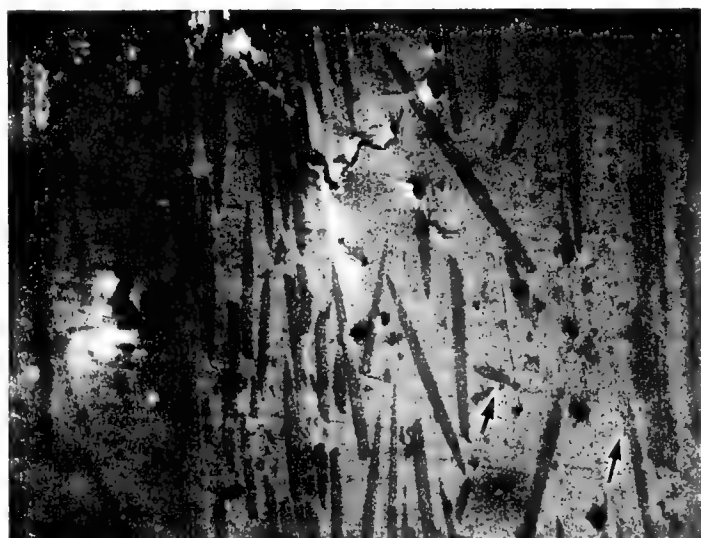
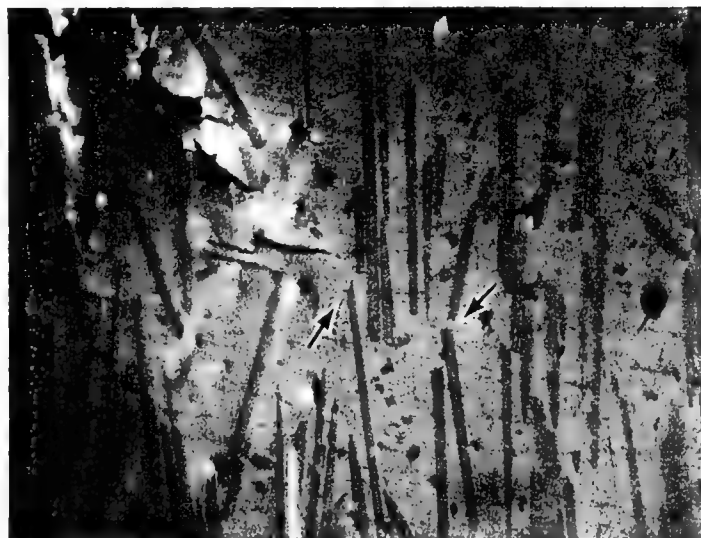
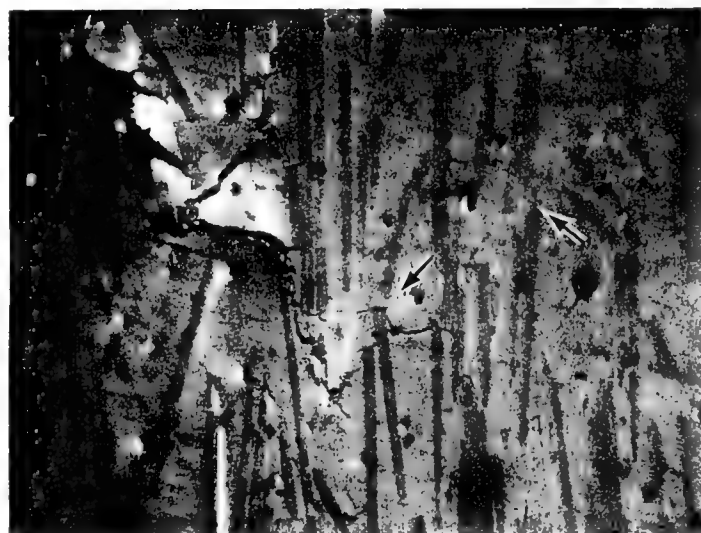
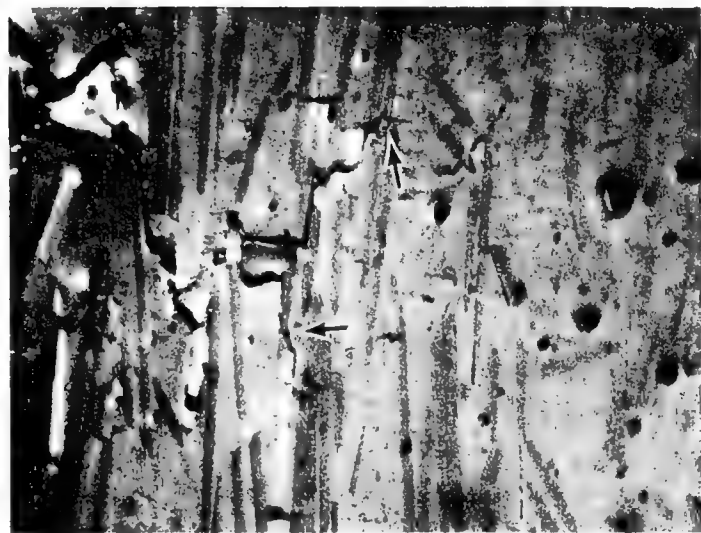
FIGURE 3 .

CRACK TIP IN POLYPHENYLENE SULFIDE UNDER
INCREASING LOAD (a) - (d); ARROWS INDICATE
PATH CRACK WILL FOLLOW; ($d_f \cong 11 \mu m$).

Figures 3 and 4 show the local mode of crack growth for the very brittle PPS matrix with glass and carbon fibers. The details of each are surprisingly different. The development of the crack tip zone is shown for the glass system in Figure 3 at four successively higher loads. The crack path can be correlated from one micrograph to the next by the arrow locations. There is a region ahead of the main crack in which small separate cracks are formed, mostly around fiber ends. These cracks coalesce at higher loads to form the main crack. This mode results in cracks primarily in the matrix and across fiber

ends, with little fiber pullout. Occasional fibers are broken by the crack, such as the one indicated by the lower arrow in (d). The PPS systems tend to contain many voids, which appear as dark circles in Figure 3.

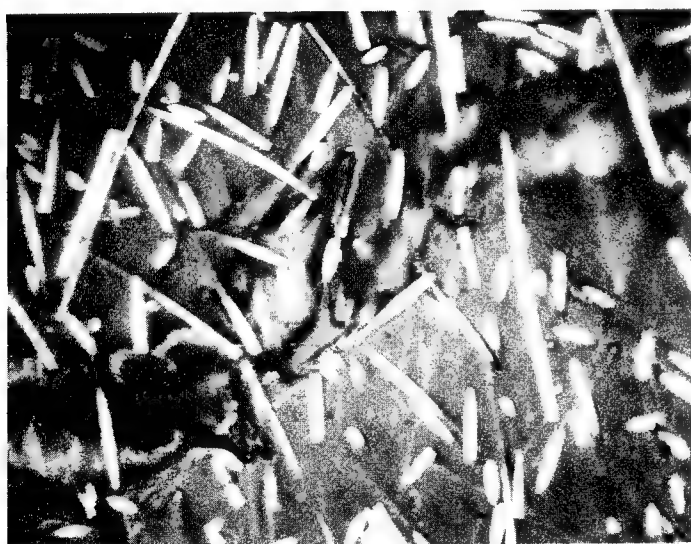
FIGURE 6 .

CRACKS IN CARBON REINFORCED POLYSULFONE (a);
AND NYLON 66 (b) ALONG CRACK, AND (c) AT TIP;
($d_f \cong 10 \mu\text{m}$).

the carbon reinforced polycarbonate, which is typical of most of the ductile matrix systems. The main crack tip shown in (d) is actually a local continuous band of yielding and necking, with some fiber pull-out. Further back along the main crack (c) the yielded material tears apart in some regions, and finally the whole yielded path tears apart to form a real crack. The arrows (lower right) in (a) and (b) show the same spot before and after crack growth. The region ahead of the crack contains many locally yielded areas, especially near fiber ends, such as at the arrow. These coalesce to form the main continuous yielded zone, which later tears apart to form the crack. As in the PPS/glass, this coalescence mode allows the crack to seek out the path of least resistance, with occasional fibers crossed by the main yield zone extracted from the matrix. Figure 6 shows the same features for carbon reinforced polysulfone and Nylon 66.

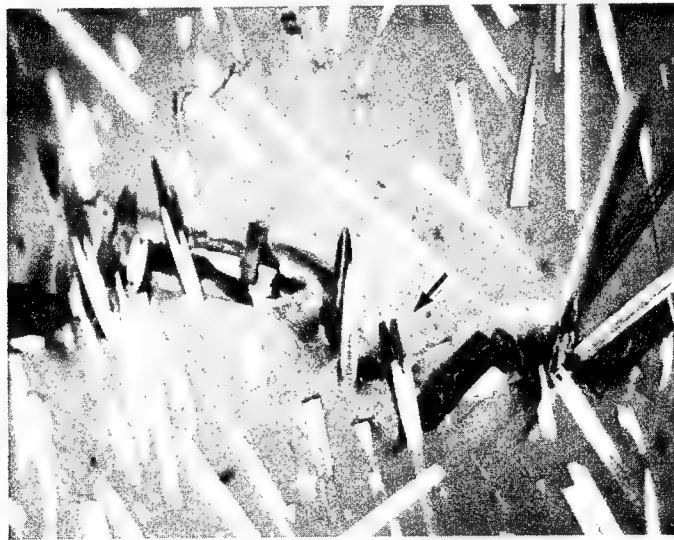
FIGURE 8 .

CRACK TIP (a) IN CARBON REINFORCED POLY(AMIDE-IMIDE), AND SAME REGION AFTER CRACK EXTENSION (b); ARROWS INDICATE CRACK PATH; ($d_f \cong 15 \mu m$).

The poly(amide-imide) matrix does not neck and draw in uniaxial tension, but shows considerable local ductility in the composite. Figure 8 shows a crack tip and subsequent growth for the carbon reinforced system. The carbon fibers in this material are kidney-shaped in cross-section, giving a split appearance when polished part-way through. Local tearing of the yielded material is evident to the left

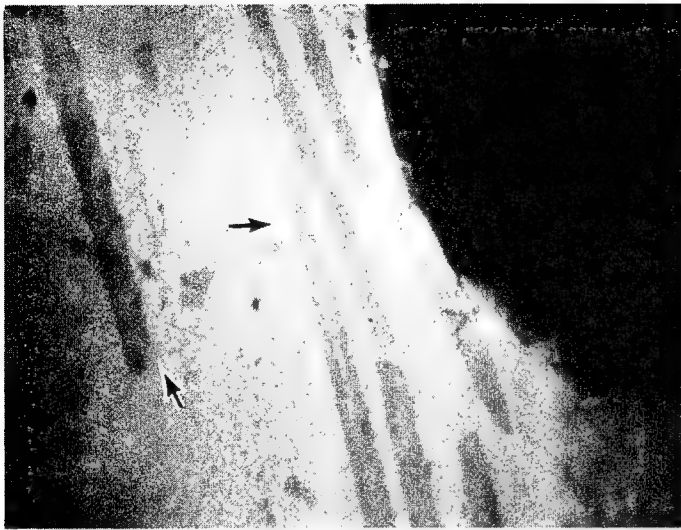
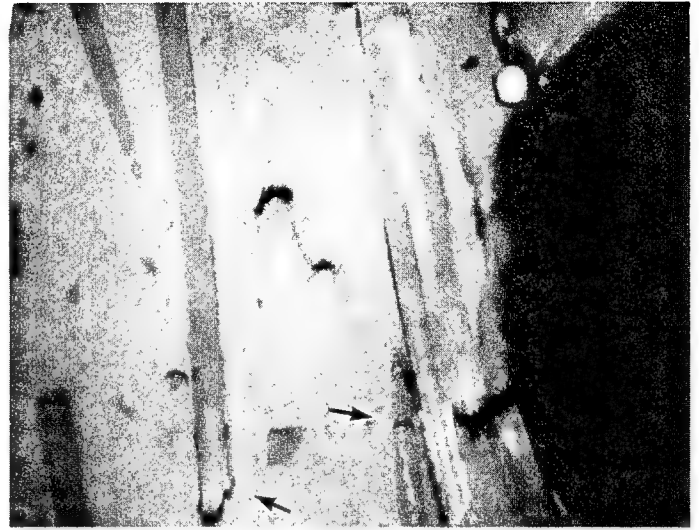
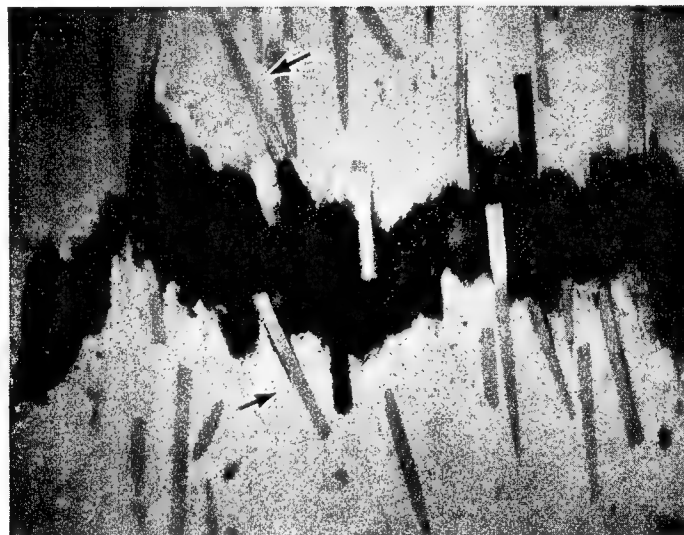
FIGURE 9.

GLASS REINFORCED POLY(AMIDE-IMIDE) SHOWING DAMAGE DEVELOPMENT AT NOTCH ROOT AT LOW (a) AND HIGH (b) LOADS, AND CRACK PATH (c); ($d_f \cong 11 \mu m$).

of the arrow in (b). Figure 9 shows the development of damage at a notch root in the glass reinforced system. The arrows in (a) and (b) trace the development of fiber debonding (which occurred first), yielding, and fiber fracture. (The fiber at the immediate notch boundary was cracked during notching.) The crack path (c) shows a broken fiber (arrows), and debonded, pulled-out fibers. Yielding was very localized in the PAI systems, but the brittle cracking observed in glass/PPS around fiber ends was not evident. Instead, the high strain capacity of the matrix appeared to result in fiber debonding and fracture, along with some local yielding.

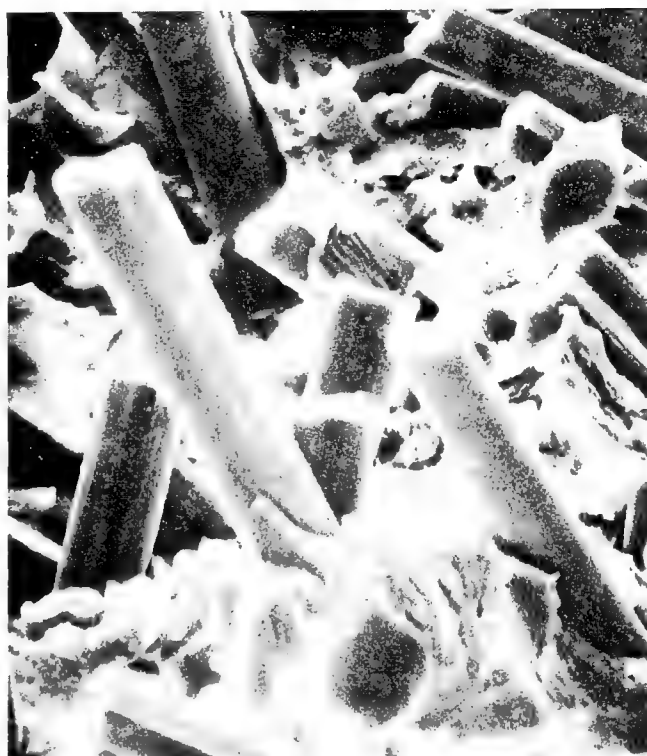
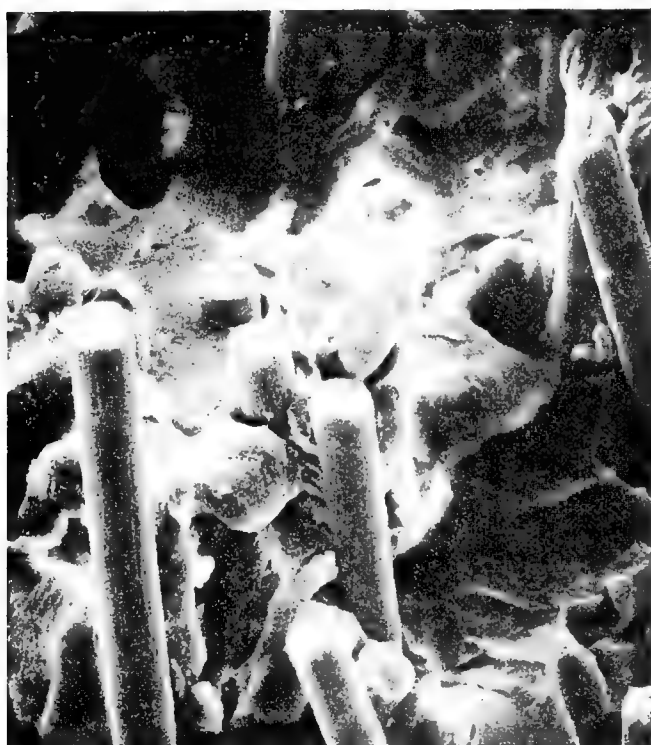
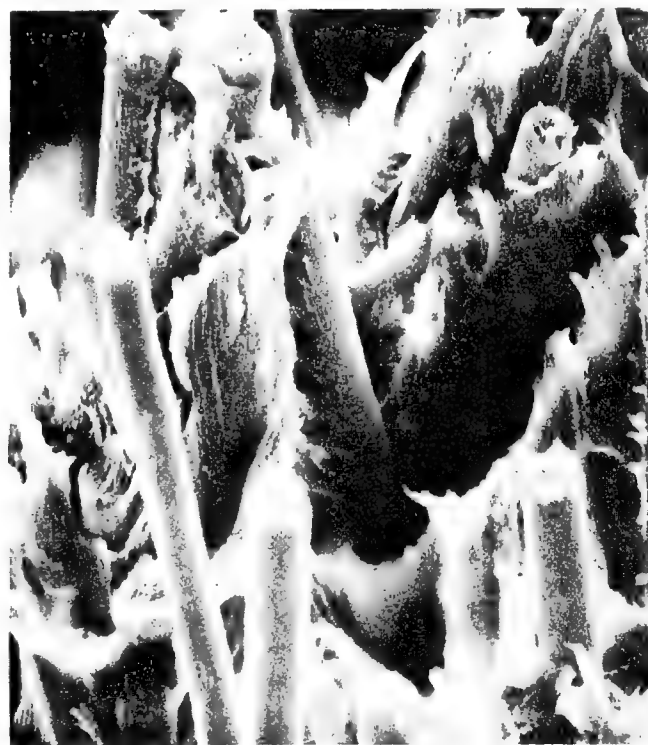
FIGURE 10.

FRACTURE SURFACES OF CARBON REINFORCED MATRICES;
CLOCKWISE FROM UPPER LEFT: POLYPHENYLENE SUL-
FIDE, POLY(AMIDE-IMIDE), NYLON 66, POLYCARBONATE;
($d_f \cong 10 \mu m$).

Differences in the local mode of crack growth are also observed in SEM micrographs of the fracture surfaces. The carbon reinforced systems in Figure 10 show variations from brittle matrix fracture for PPS to very ductile for N66, with some ductility evident for PC and PAI. The same sequence with glass fibers in Figure 11 (lower magnification than Fig. 10) shows similar effects. However, relatively few fibers are observed on the PPS surface, reflecting the local mode of formation of the crack in Figure 3.

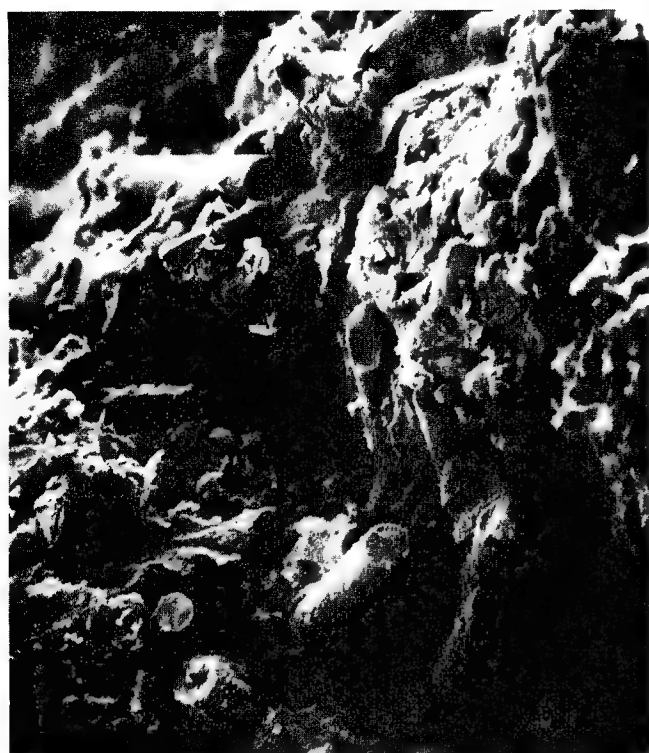
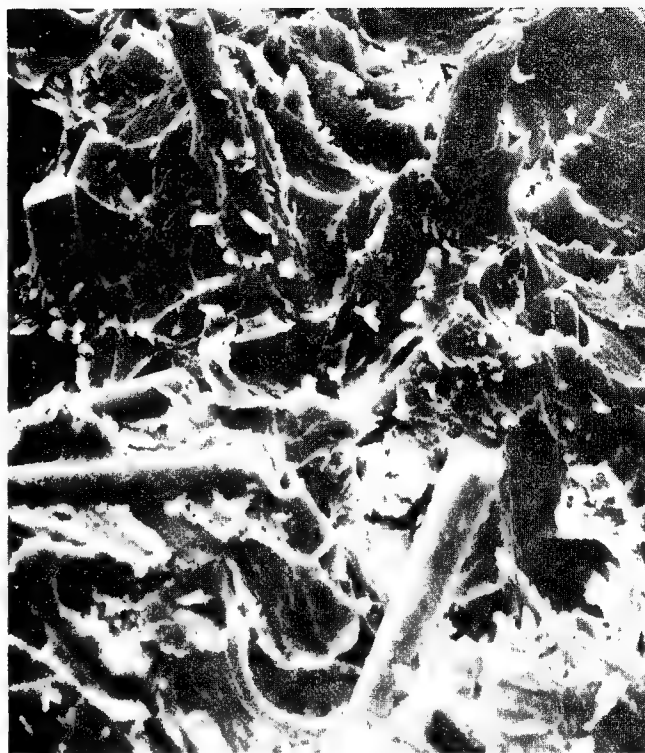
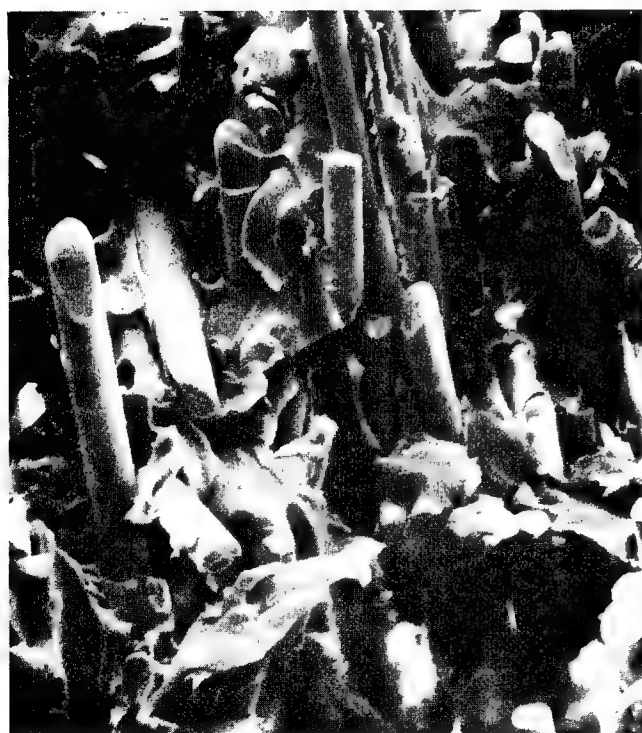
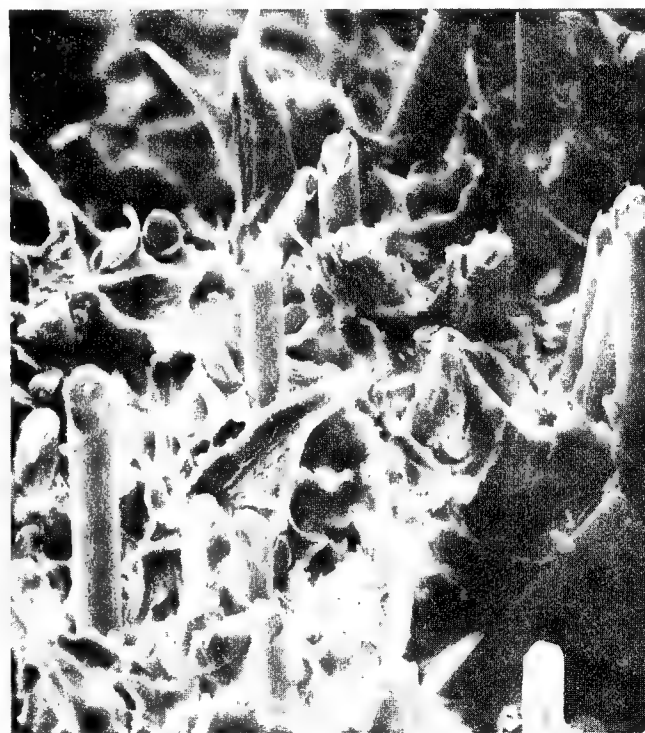
FIGURE 11.

FRACTURE SURFACES OF GLASS REINFORCED MATRICES;
CLOCKWISE FROM UPPER LEFT: POLYPHENYLENE SUL-
FIDE, POLY(AMIDE-IMIDE), NYLON 66, POLYCARBONATE;
($d_f \cong 11 \mu m$).
